Level I – FULL Reserve Study Report

Wolf Creek

Winthrop, WA

November 22, 2022

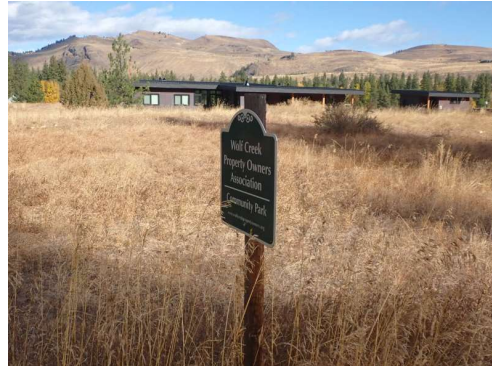
Street & Common Area Signs - Replace		27 Each	
Asset ID	1020	Asset Actual Cost	
		Percent Replacement	100%
	Grounds	Future Cost	
Placed in Service	January 2000		
No Useful Life

Location: Scattered locations at private streets and within common areas

Component History: No history reported, an estimated in-service date of 2000 has been used for the purposes of this report

There is no predictable basis to anticipate wide scale replacement of signage at this time and cost of individual replacement is projected to be too small for reserve funding, therefore maintain, repair and replace individual signs on an as-needed basis through the annual operating budget.

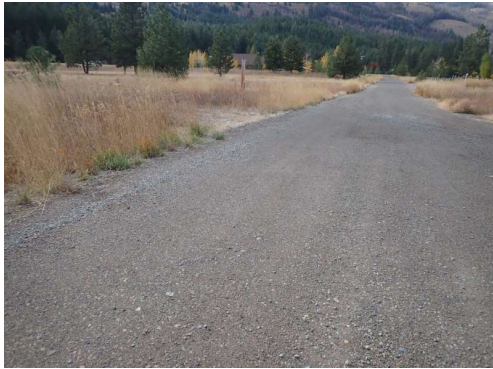
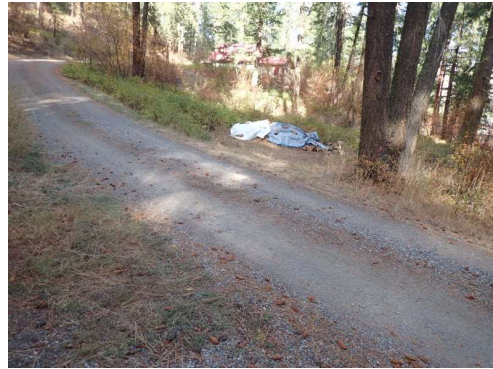
Gravel Roads - Regrade & Replenish - 2025

Asset ID	1048	1 Allowance	@ \$16,000.00
		Asset Actual Cost	\$16,000.00
		Percent Replacement	100%
		Future Cost	\$16,974.40
	Grounds		
Placed in Service	January 2022		
Useful Life	3		
Replacement Year	2025		
Remaining Life	2

Cost Range: The allowance included here is a basic flat fee allowance. Actual cost may vary based on final scope of work including amount of gravel purchased.

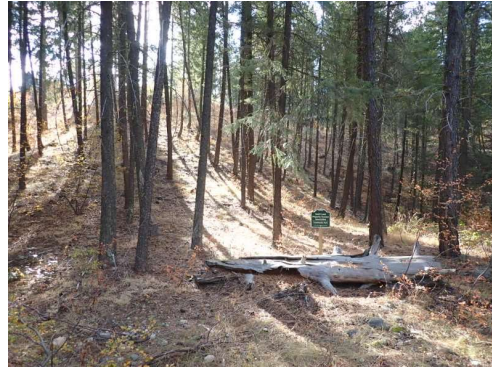
Landscape - Refurbish Allotment

Location: Common area landscaping

Component History: No history reported

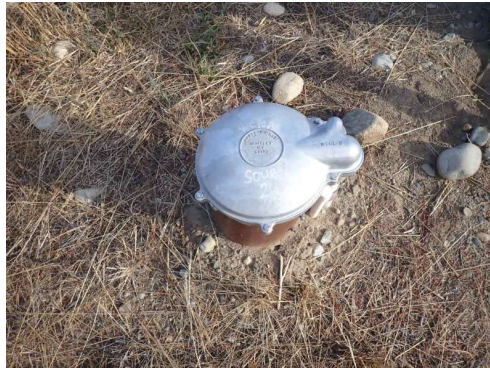
Well Casings - Replace - 2053		2 Each	@ \$75,000.00
Asset ID	7000	Asset Actual Cost	\$150,000.00
		Percent Replacement	100%
		Future Cost	\$364,089.37
	Water System		
Placed in Service	January 1978		
Useful Life	75		
Replacement Year	2053		
Remaining Life	30

Cost Range: The allowance included here is a basic flat fee allowance. Actual cost may vary based on final scope of work and depth of wells.

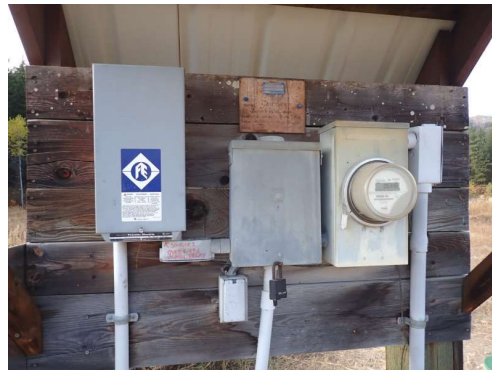
Well Controls/Telemetry - Replace - 2023

1 System	@ \$25,000.00
Asset ID	7005	Asset Actual Cost	\$25,000.00
		Percent Replacement	100%
		Future Cost	\$25,000.00
		Water System	
Placed in Service	January 2000		
Useful Life	20		
Replacement Year	2023		
Remaining Life	0

Cost Range: The allowance included here is a basic flat fee allowance. Actual cost may vary based on final scope of work and features/function of system.

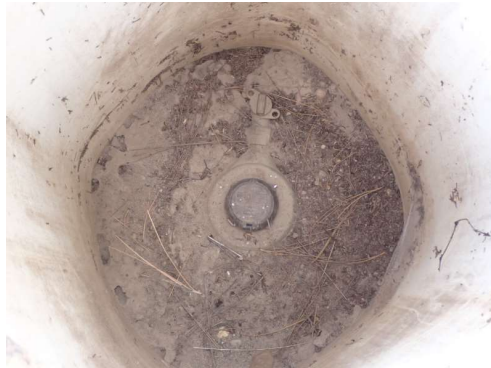
Water Meters - Replace (Service) - 2023		70 Each	@ \$250.00
Asset ID	7025	Asset Actual Cost	\$17,500.00
		Percent Replacement	100%
		Future Cost	\$17,500.00
Placed in Service	Water System		
Useful Life	January 2002		
Replacement Year	20		
Remaining Life	2023		
	0

Cost Range: The allowance included here is a basic flat fee allowance. Actual cost may vary based on quality and functions of meter selected.

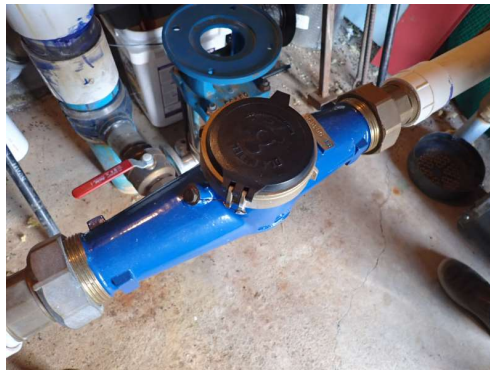
Water Meters - Replace (Source/Distribution) - 2041

Asset ID	7030	1 Allowance	@ \$2,150.00
		Asset Actual Cost	\$2,150.00
		Percent Replacement	100%
		Future Cost	\$3,660.23
Placed in Service	Water System		
	January 2021		
Useful Life	20		
Replacement Year	2041		
Remaining Life	18

2 - Source Meters	@	\$500.00	\$1,000.00
1 - 4" Transmission Line Meter	@	\$1,150.00	<u>\$1,150.00</u>
		Total =	\$2,150.00

Cost Range: The allowance included here is a basic flat fee allowance. Actual cost may vary based on quality and functions of meter selected.

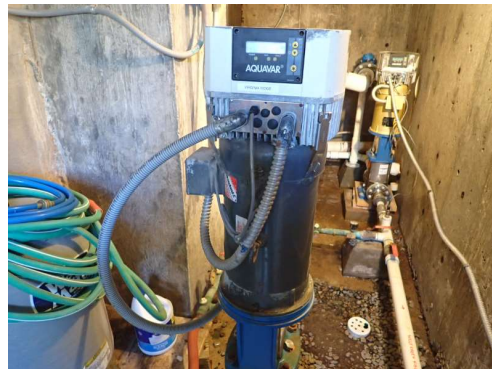
Booster Pump - Replace (Virginia Ridge) - 2023

Asset ID	7035	1 Each	@ \$6,500.00
		Asset Actual Cost	\$6,500.00
		Percent Replacement	100%
		Future Cost	\$6,500.00
Placed in Service	Water System		
Useful Life	January 2007		
Replacement Year	15		
Remaining Life	2023		
	0

Cost Range: The allowance included here is a basic flat fee allowance. Actual cost may vary based on final scope of work.

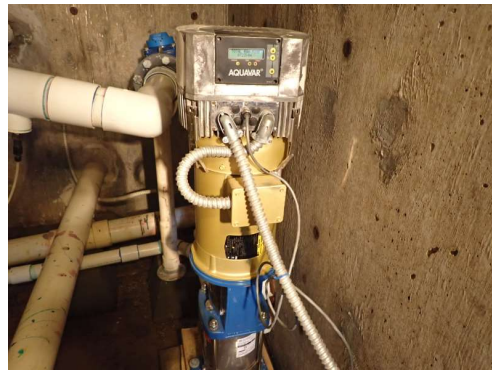
Booster Pump - Replace (Green Meadows) - 2037

1 Each	@ \$6,500.00
Asset ID	7040	Asset Actual Cost	\$6,500.00
		Percent Replacement	100%
	Water System	Future Cost	\$9,831.83
Placed in Service	January 2022		
Useful Life	15		
Replacement Year	2037		
Remaining Life	14

Cost Range: The allowance included here is a basic flat fee allowance. Actual cost may vary based on final scope of work.

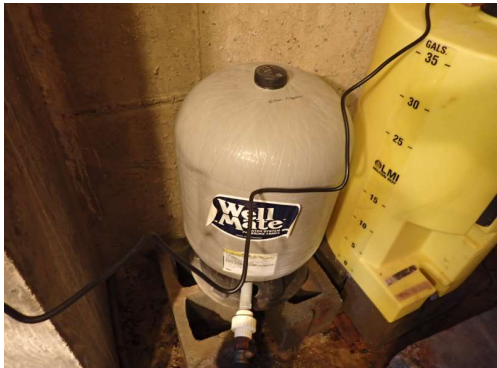
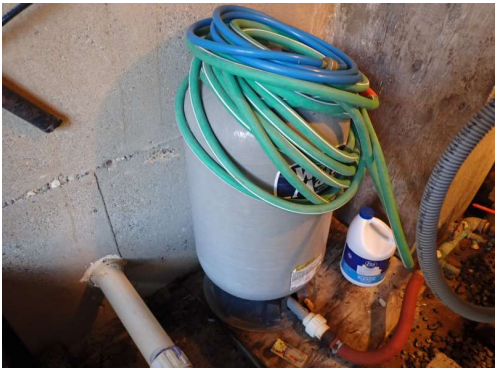
Pressure Tanks - Replace		2 Each	
Asset ID	7045	Asset Actual Cost	
		Percent Replacement	100%
		Future Cost	
Placed in Service	Water System		
No Useful Life	January 2008

Location: Within pump house at reservoir

Component History: Replaced 2008

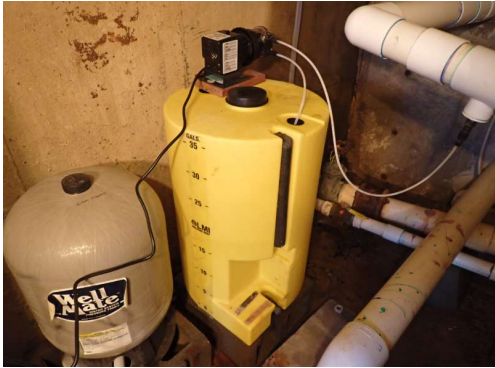
Chlorination System - Replace			
Asset ID	7050	1 System	
		Asset Actual Cost	
		Percent Replacement	100%
		Future Cost	
Placed in Service	Water System		
No Useful Life	January 2022

Location: Within pump house at reservoir

Component History: Pump replaced 2022 \$390

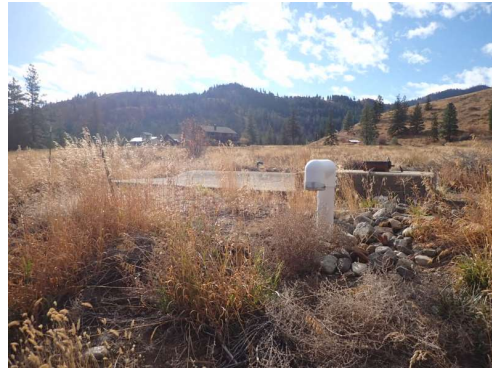
Water Storage Tank - Replace - 2029

Asset ID	7055	1 Each	@ \$250,000.00
		Asset Actual Cost	\$250,000.00
		Percent Replacement	100%
		Future Cost	\$298,513.07
Placed in Service	Water System		
Useful Life	January 1979		
Replacement Year	50		
Remaining Life	2029		
	6

Cost Range: The allowance included here is a basic flat fee allowance. Actual cost may vary based on final scope of work including extent of excavation required to replace tank.

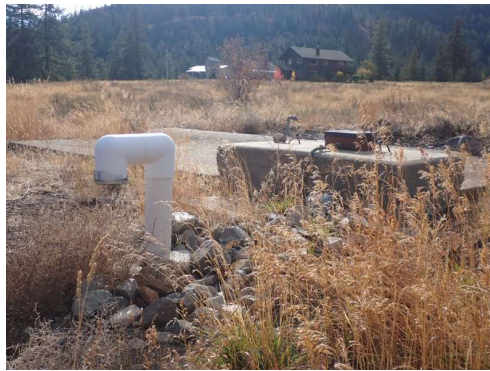
Water Storage Tank - Clean & Inspect - 2024

Asset ID	7060	1 Allowance	@ \$2,600.00
		Asset Actual Cost	\$2,600.00
		Percent Replacement	100%
		Future Cost	\$2,678.00
Placed in Service	Water System		
Useful Life	January 2021		
Replacement Year	3		
Remaining Life	2024		
	1

Cost Range: The allowance included here is a basic flat fee allowance. Actual cost may vary based on final scope of work including extent of cleaning necessary.

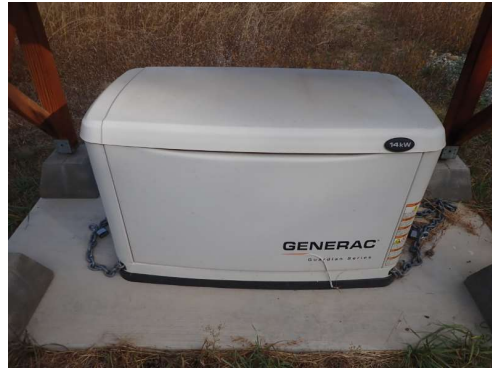
Generator - Replace - 2025

Asset ID	7065	1 Each	@ \$5,500.00
		Asset Actual Cost	\$5,500.00
		Percent Replacement	100%
		Future Cost	\$5,834.95
Placed in Service	Water System		
Useful Life	January 2015		
Replacement Year	10		
Remaining Life	2025		
	2

Cost Range: The allowance included here is a basic flat fee allowance. Actual cost may vary based on final scope of work including quality of generator selected.

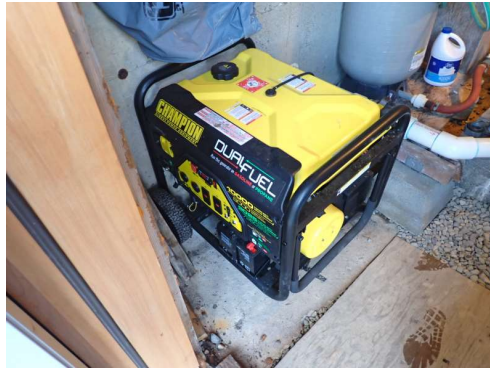
Generator - Replace (Portable) - 2032

Asset ID	7070	1 Each	@ \$1,300.00
		Asset Actual Cost	\$1,300.00
		Percent Replacement	100%
		Future Cost	\$1,696.20
Placed in Service	Water System		
Useful Life	January 2022		
Replacement Year	10		
Remaining Life	2032		
	9

Cost Range: The allowance included here is a basic flat fee allowance. Actual cost may vary based on size and quality of generator equipment selected.

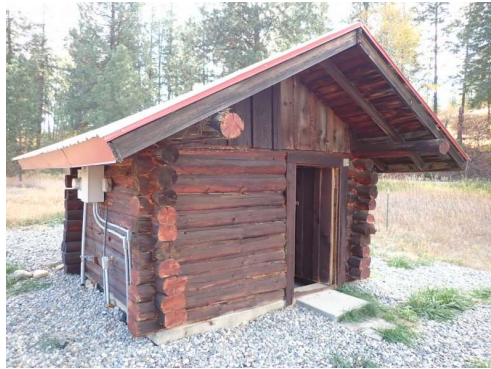
Pump House Exterior - Refurbish (Cottonwood) - 2029

Asset ID	7080	1 Allowance	@ \$3,000.00
		Asset Actual Cost	\$3,000.00
		Percent Replacement	100%
		Future Cost	\$3,582.16
	Water System		
Placed in Service	January 1979		
Useful Life	50		
Replacement Year	2029		
Remaining Life	6

Cost Range: The allowance included here is a basic flat fee allowance. Actual cost may vary based on final scope of work.

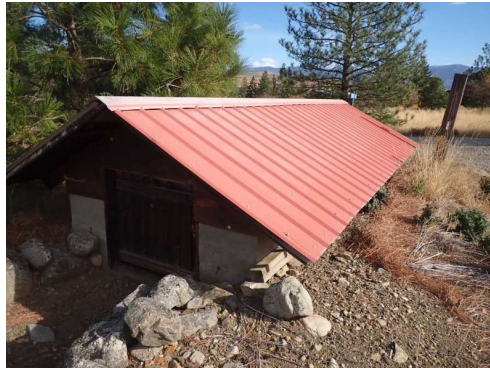
Pump House Exterior - Refurbish (Green Meadow)

Location: Adjacent to Green Meadow Drive

Component History: No history reported

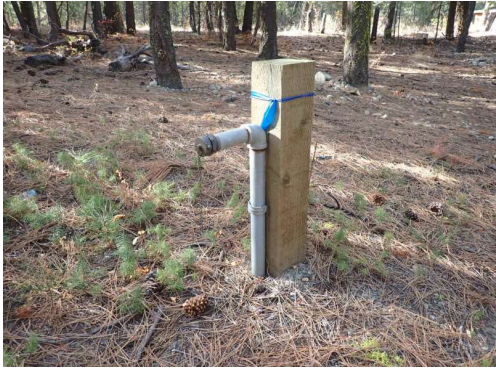
Fire Hydrants - Replace		5 Each	
Asset ID	7100	Asset Actual Cost	
		Percent Replacement	100%
		Future Cost	
Placed in Service	Water System		
No Useful Life	January 1979

Location: Adjacent to roadways throughout community

Component History: No history reported

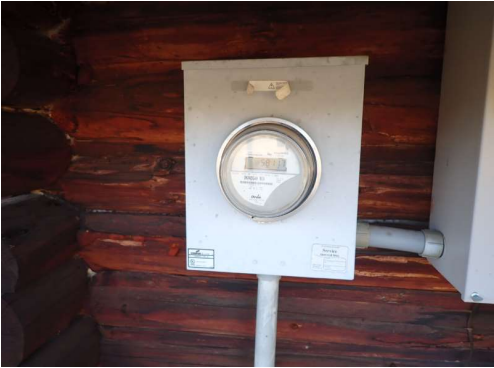
Electrical System - Replace			
Asset ID	7110	1 Allowance	
		Asset Actual Cost	
		Percent Replacement	100%
		Future Cost	
Placed in Service	Water System		
No Useful Life	January 1979

Location: Common area electrical

Component History: No history reported
